Manhole Inspection Summary

Manhole # S37U__005MH

Location Address: **rear 435 e. fort ave**

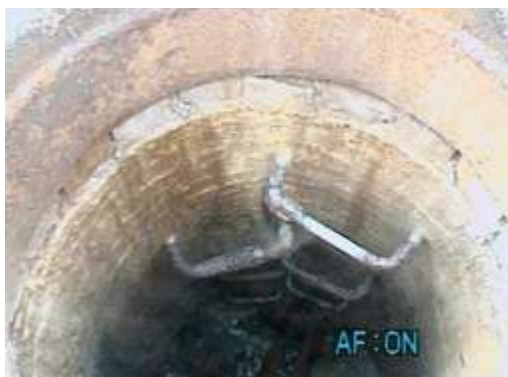
Defect 1

Condition: ☐ Sound ☒ **Cracked** ☐ Root Intrusion ☒ **Loose Brick** ☐ Deteriorated

Steps Count: **6** Missing: **0** ☒ **Corroded**

corroded steps, cracks, loose bricks in chimney

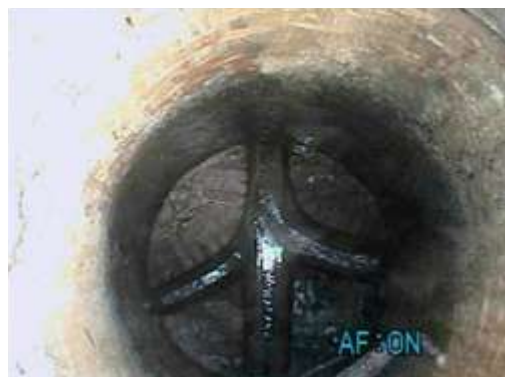
Miscellaneous

surcharge evidence
